As informed you today hereby a report after visiting our project in Nuwakot today. During the visit I checked the solar system, installed by Lasersun Pulchowk Kathmandu, and the biogas installations, installed by Universal Consultancy.

The solar system has been finished by Lasersun about two weeks ago. In my belief there is some unfinished work, also some things have been done wrong and created even a deadly risk which is not acceptable. In this report I will explain the different issues.

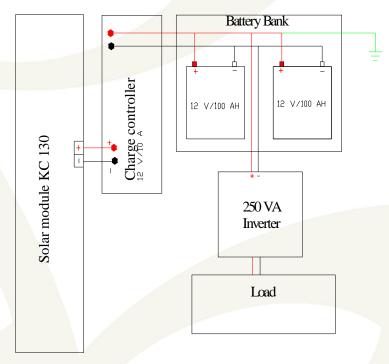
As you can see the batteries are standing to low. They contain poison (also mentioned on the sticker on the batteries). Children can easily touch or open them with health risk as result.

Place them high or cover them
