November 14th, Kathmandu

During this visit your staff was very helpful to provide information about the system and providing us drinks and food. During the same visit I checked the changes made by Lasersun in relation with my previous report from November 9th.

On the following pages information about the improvement from Lasersun

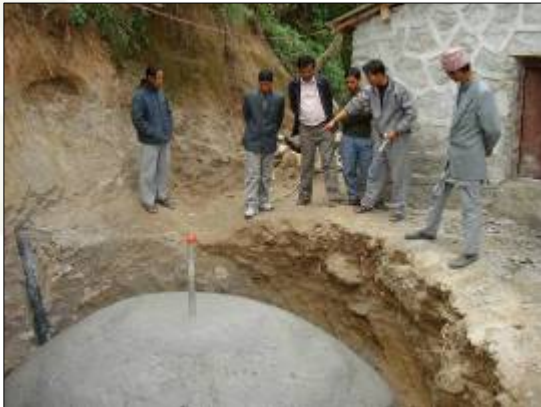
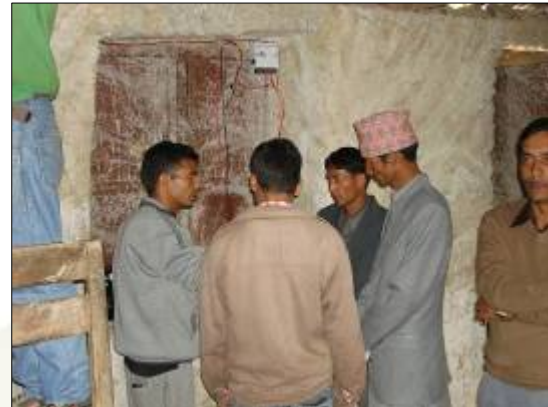
Informing the visitors from Jumla

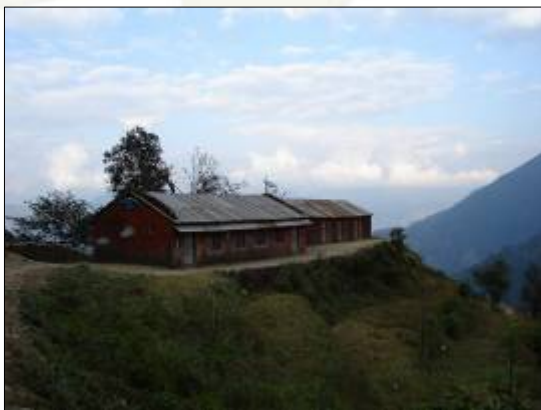
The fourth installation has been build where Lasersun directly worked in an improved way.

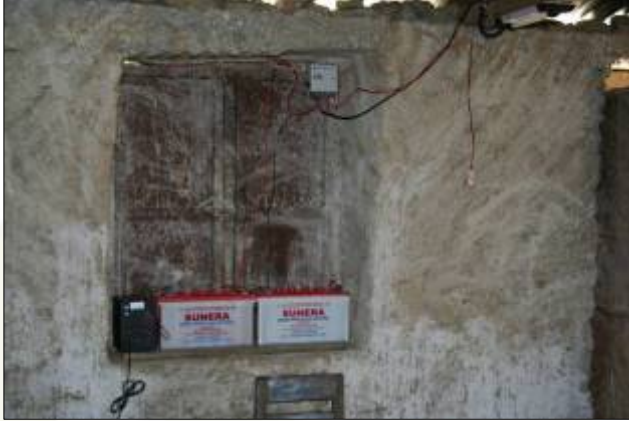
Old situation

As you can see the batteries are standing to low. They contain poison (also mentioned on the sticker on the batteries). Children can easily touch or open them with health risk as result.

Place them high or cover them

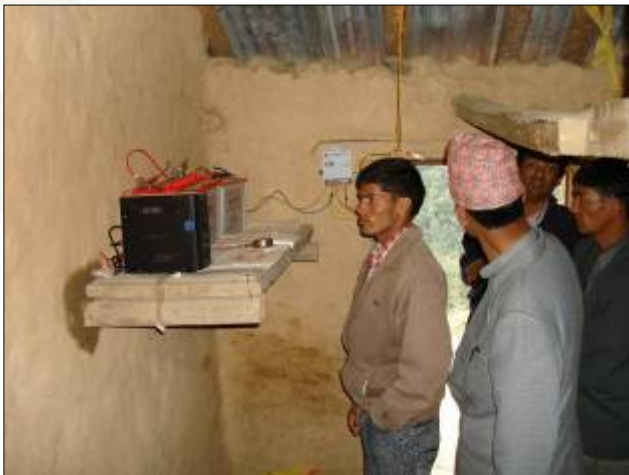
New situation

Placed on a more safe location

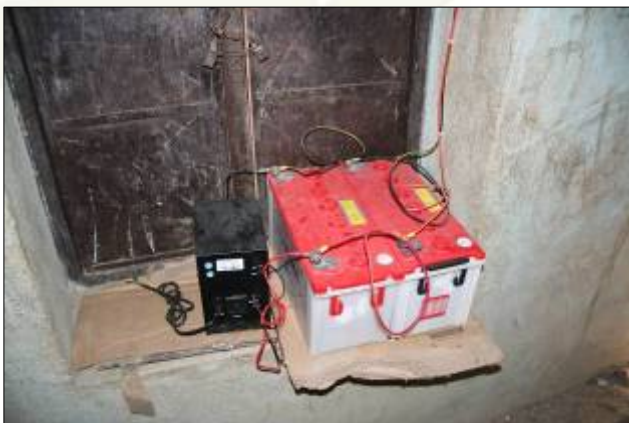
Old situation

The batteries are standing to the metal windowcloser. Because the sun burns onto the metal plate these where very hot, to hot to touch.

The temperature of the batteries was quite high. Their lifetime will be shortened and there is even a change of explosion!

Remove as soon as possible!

Not yet changed, to be informed by Umbrella

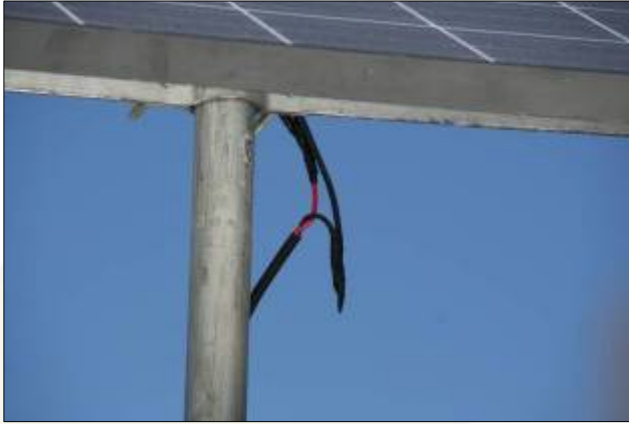
Old situation

The connections of the wiring is not acceptable. The engineers connected them by hand and put tape on it, inside the building and outside. This tape will get loose within a few months with blank wires as result.

Risk outside low (12V): loose wires

Risk inside big (220V): blank wires + and – close to each other. Fire or electrocution as result.

Use regular joints for it.

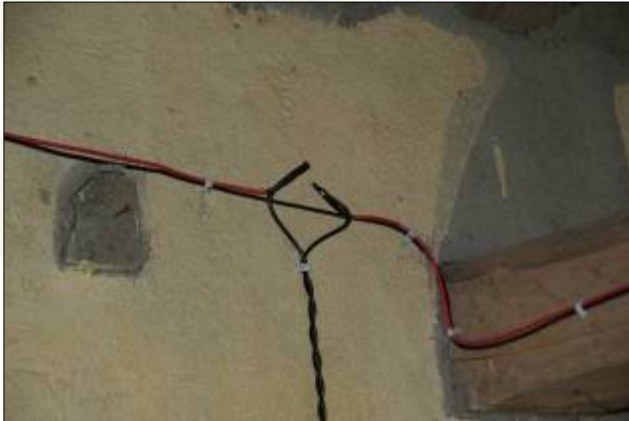
This is a picture taken inside. You can see how close the + and – are next to each other. If the tapes are gone the risk is enormous.

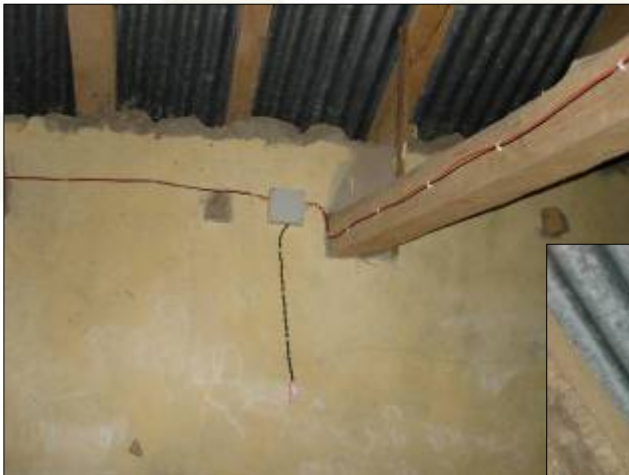
New Situation

Rewired and more safe connection

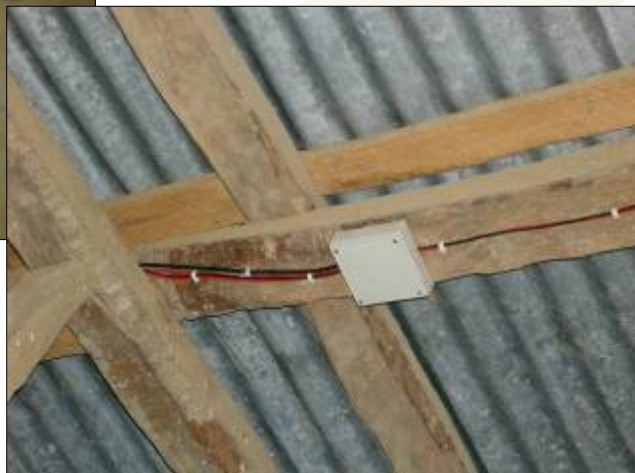
Lighting arrestor

The lightning arrestor system is completely insufficient and needs replacement. Even one of the three systems lacked the lightning arrestor.

Replace the whole lightning arrestor system

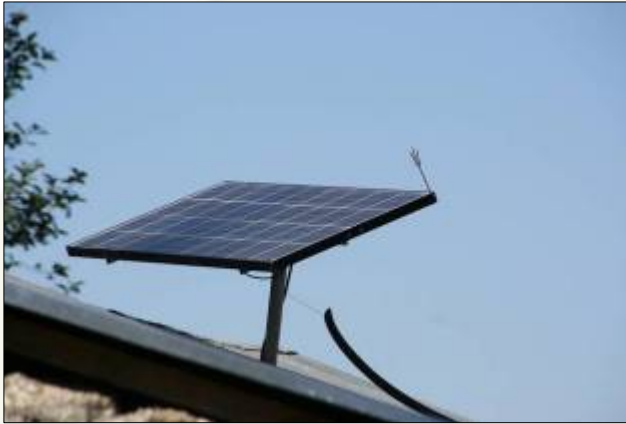
Old Situation

For a good lightning arrestor system you need a metal pole with a diameter of at least 1cm standing next to the solar panel, about 1 meter higher than the highest point of the solar system. This 'fork' is too small.

Also the cable is too small. This one also needs to be at least 1cm. The cable being used now is even smaller than a 12V cable. If lightning strikes at this moment the whole cable is gone and completely not functioning.

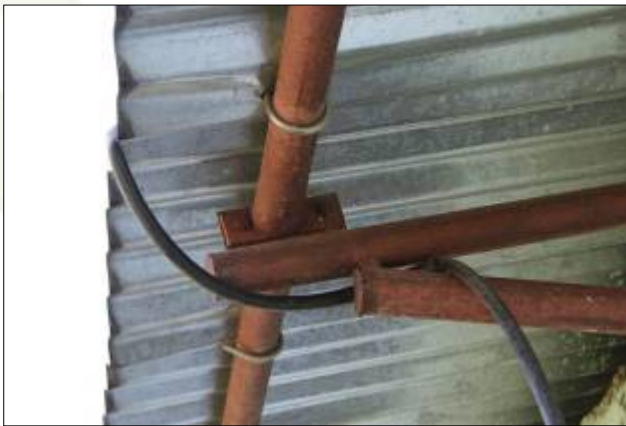
The isolation between the cable and the construction is too thin. If lightning would occur then it will electrify the metal construction.

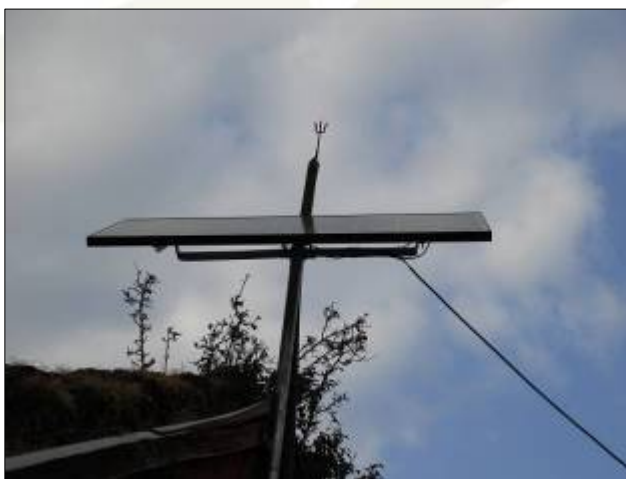
New Situation

Thicker wires have been used. Also the lightning arrestor has been placed on a better location.
