Dihitar Irrigation

Infrastructure Support to Improve the Lives of the
Marginalized Communities of Lothar

A photo Report

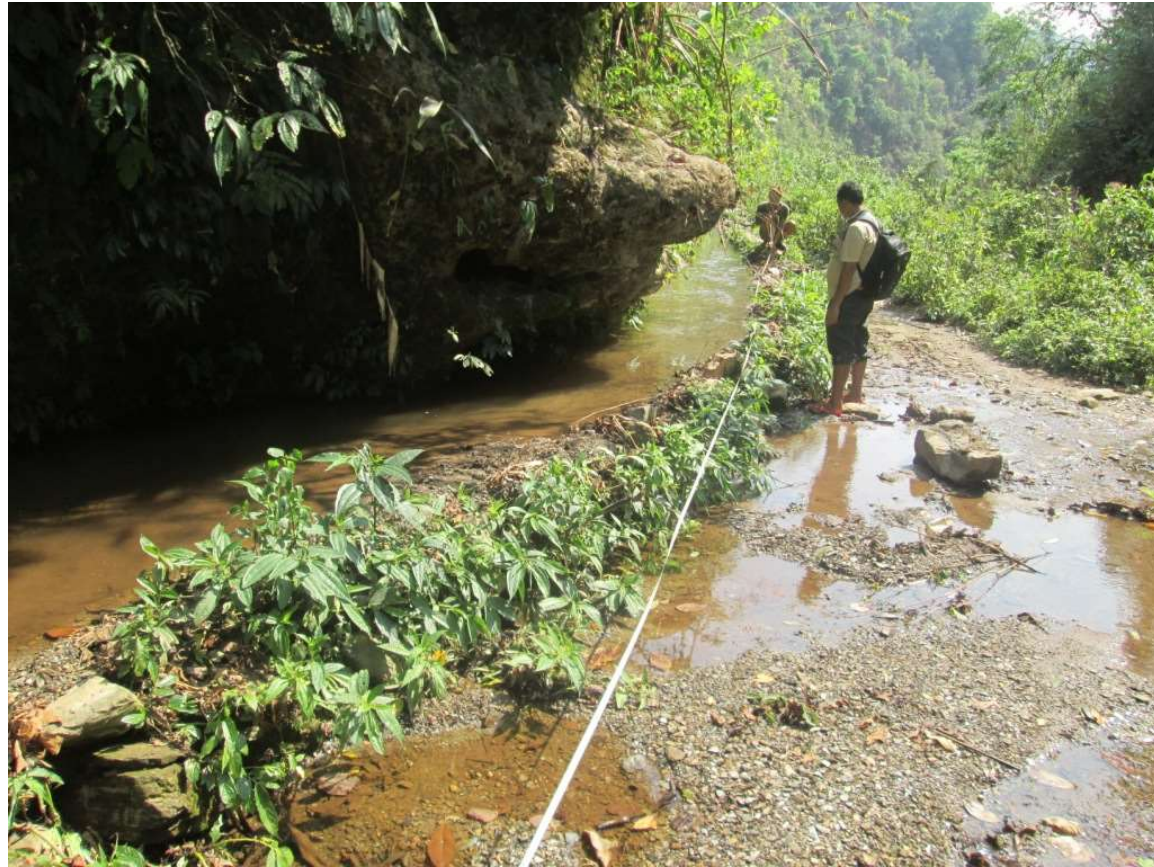
Re- Surveying of Irrigation Canal

Before the initiation of the project, a 2nd technical survey is done; this makes the project run smoother and with minimum technical obstacles. The weaknesses, if any, of the 1st survey are found then improvisation and technical changes are adopted and subsequently changed in the budget and the scheduling of the program.

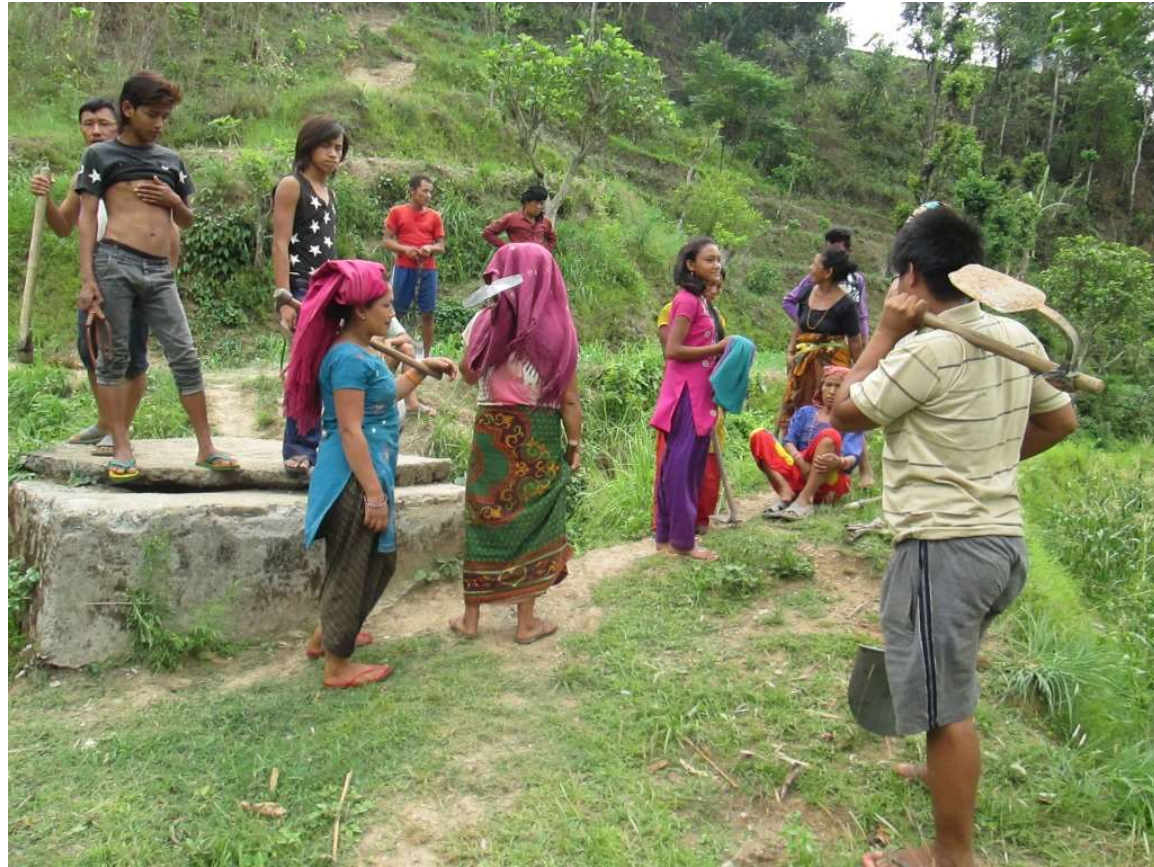
Gathering to go for work

The locals gather for instruction and information before going off to work on the project. Shanti Griha emphasizes on community contribution - volunteer labor and in-kind support: a project cannot be successful without the support of the local community. Mutually beneficial collaboration and moral support are a vital part of any Shanti Griha project.

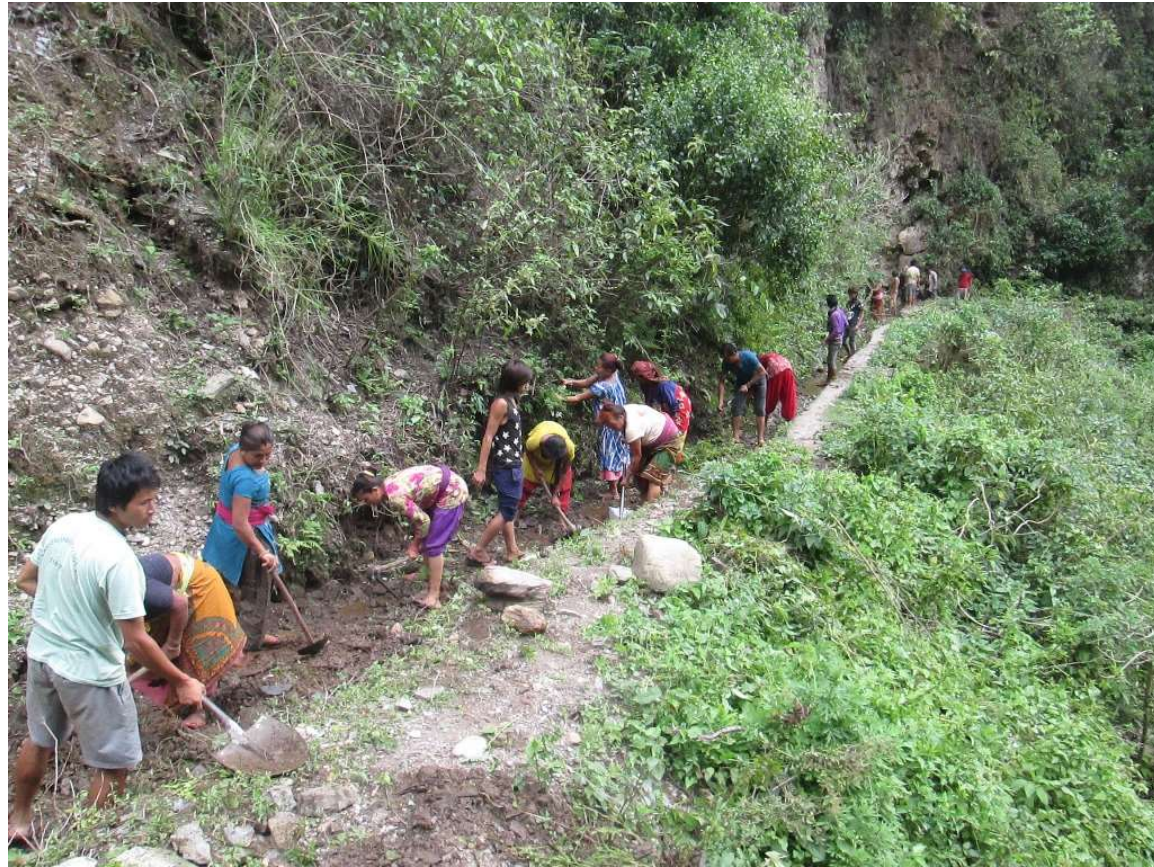
Site Clearance of Canal

The local inhabitants are working on site clearance of the canal that will be improved and capable of carrying water to their fields; better harvest, more crops and vegetables, and improved food security.

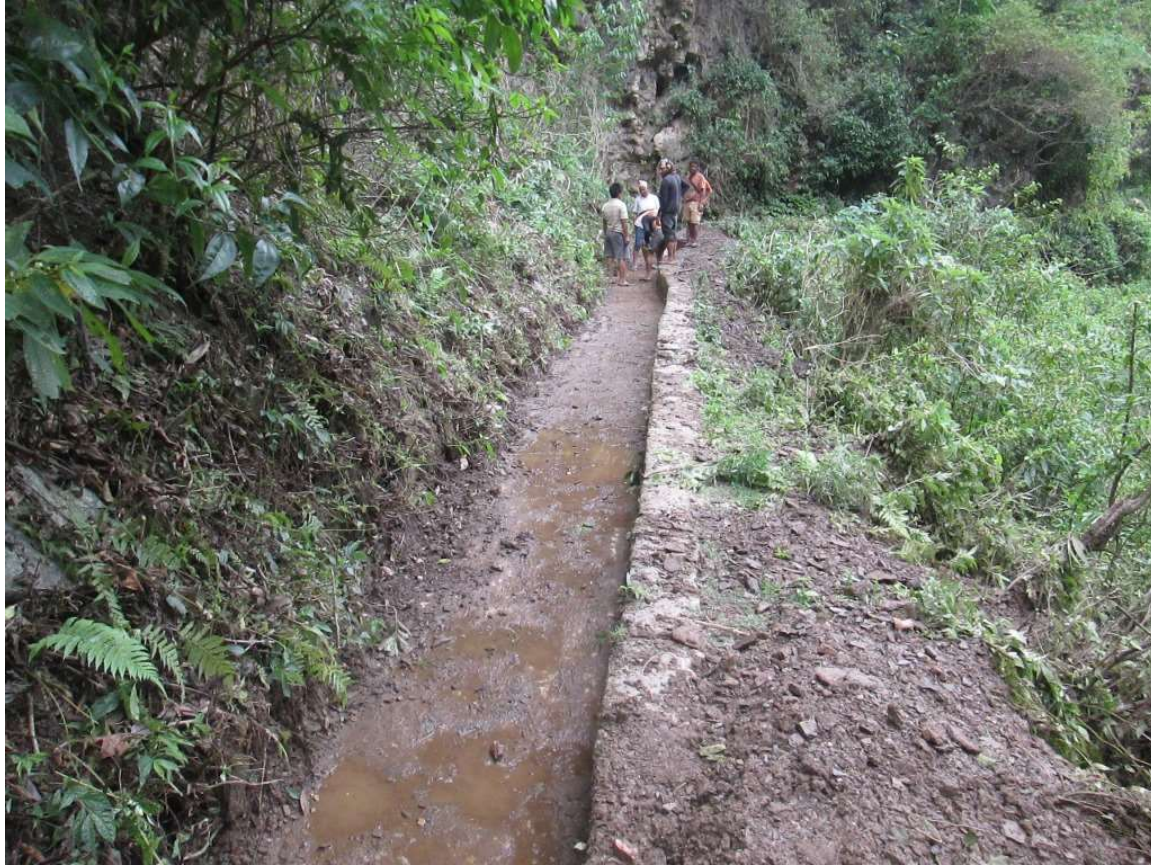
Canal after site clearance

The old canal is clean of debris and ready to be improved and made better. It is a dangerous place to work with leeches, roots and stones getting in the way, and the working space a little congested.

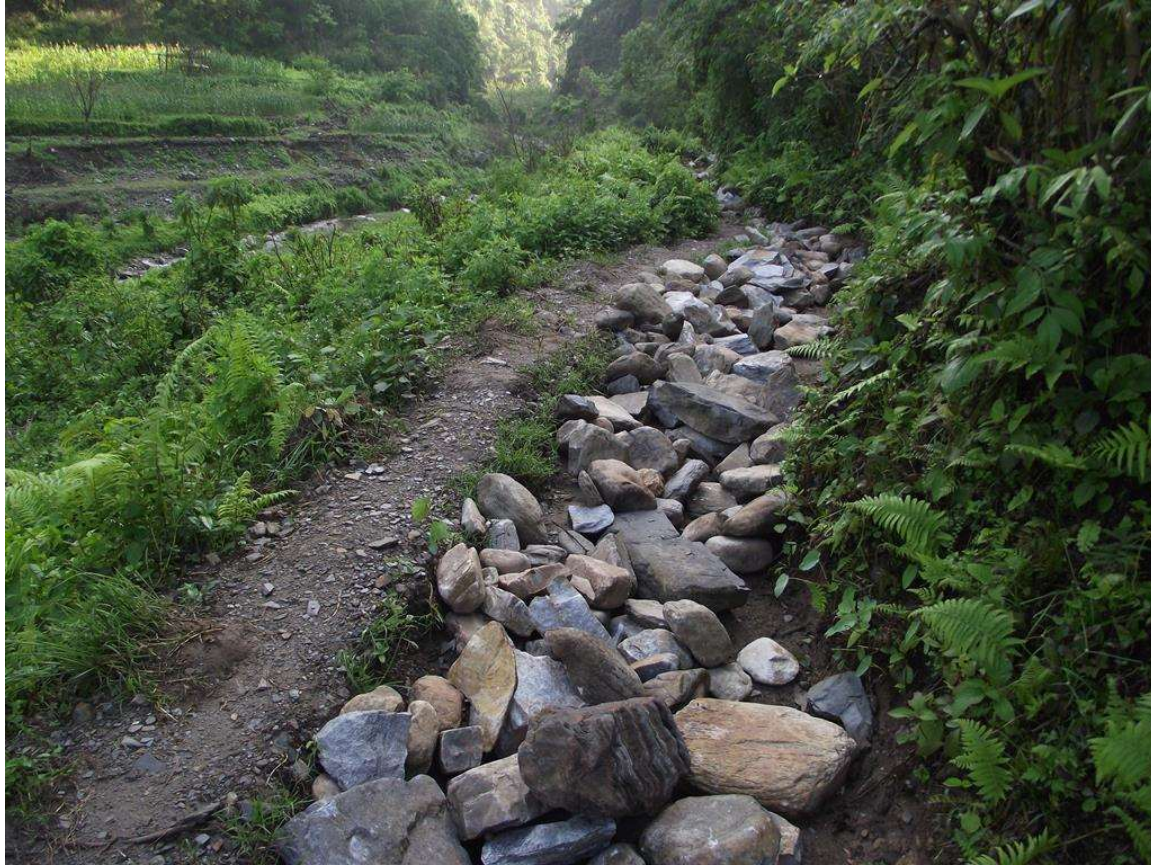
Canal Stone Soling

The old canals were just trenches, with water flow restricted and leakages that prevented sufficient water for the fields.

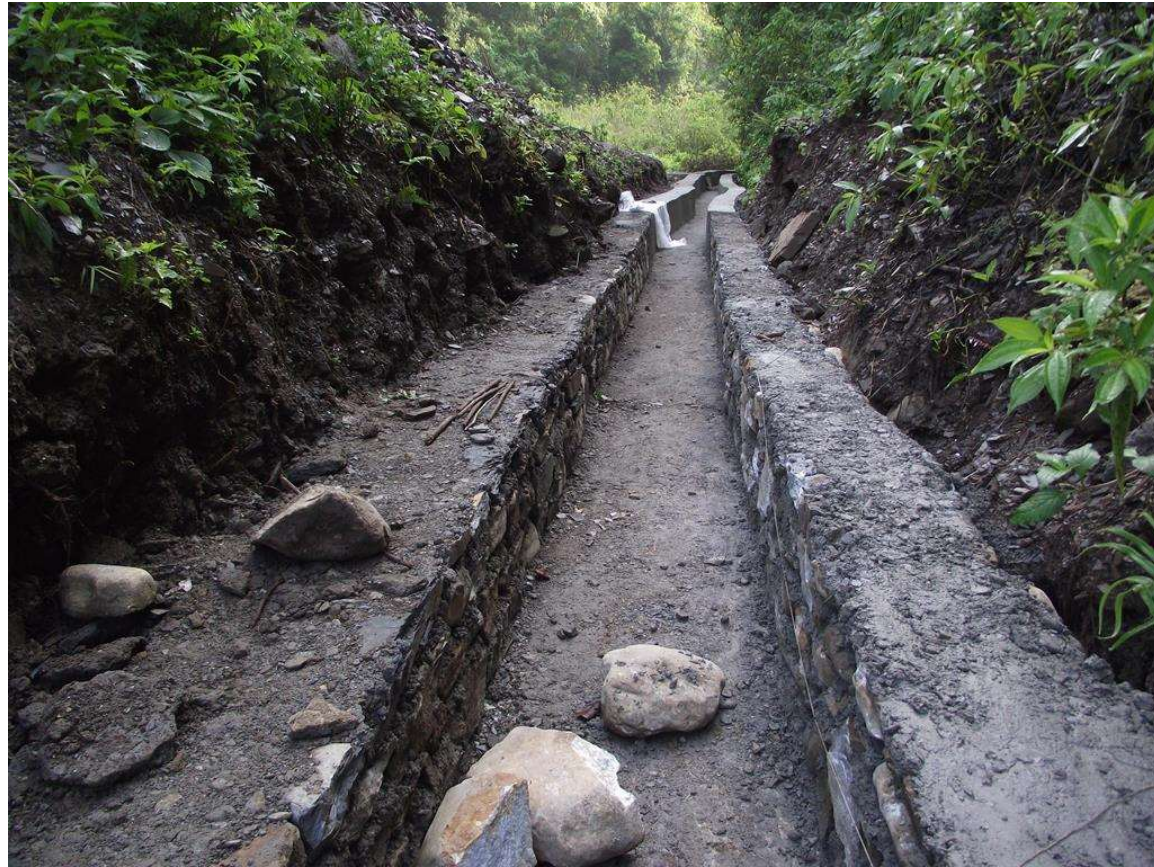
Stone Masonry Cement Mortar Wall Construction of Canal

Stones and cement have been used to reinforce the canal walls; less chance of leakages and big enough for a better water flow.

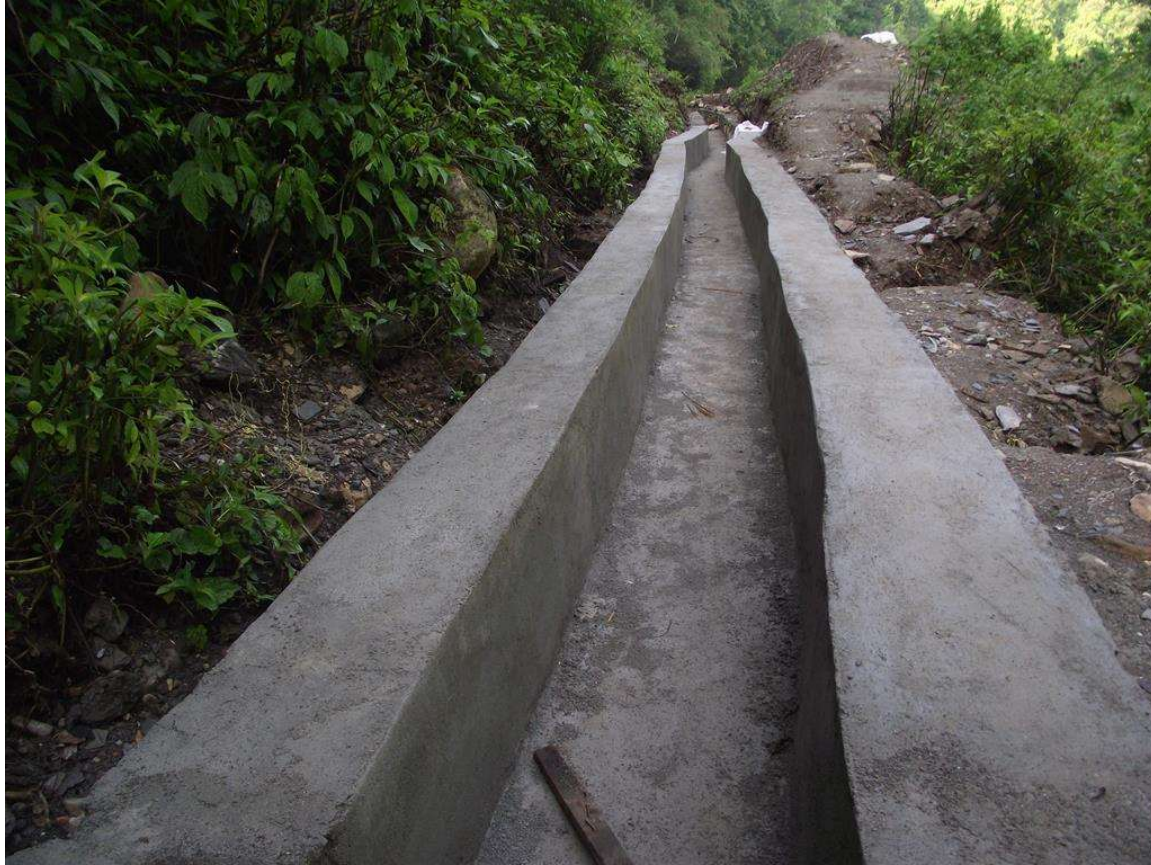
Cement Plaster of Canal (Completed Canal)

An image of the finished product. Reinforced with stones and cement and plastered we expect this to last longer than the original canal

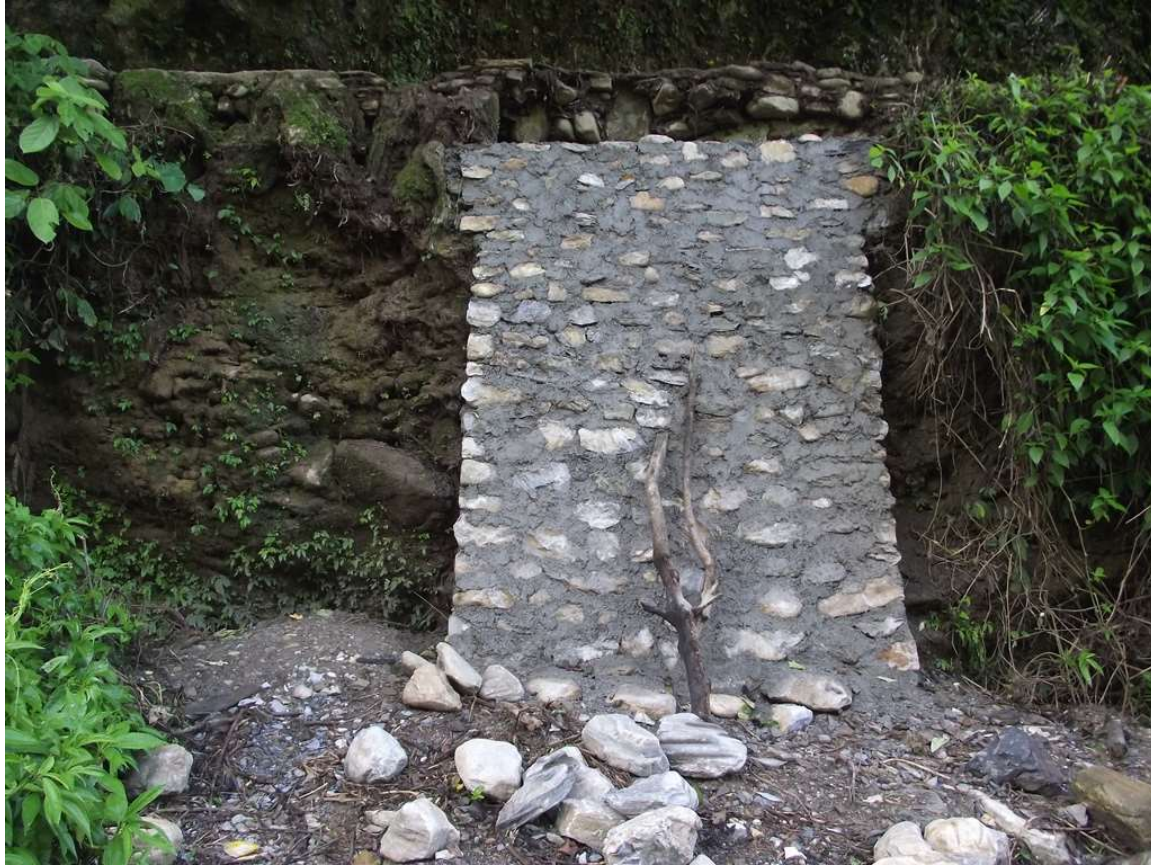
Stone wall erected at a landslide prone part

There have been some improvisations that Shanti Griha had to adopt. This stone wall was constructed at a landslide prone area of the irrigation canal. This improvisation was done after our 2nd technical survey.

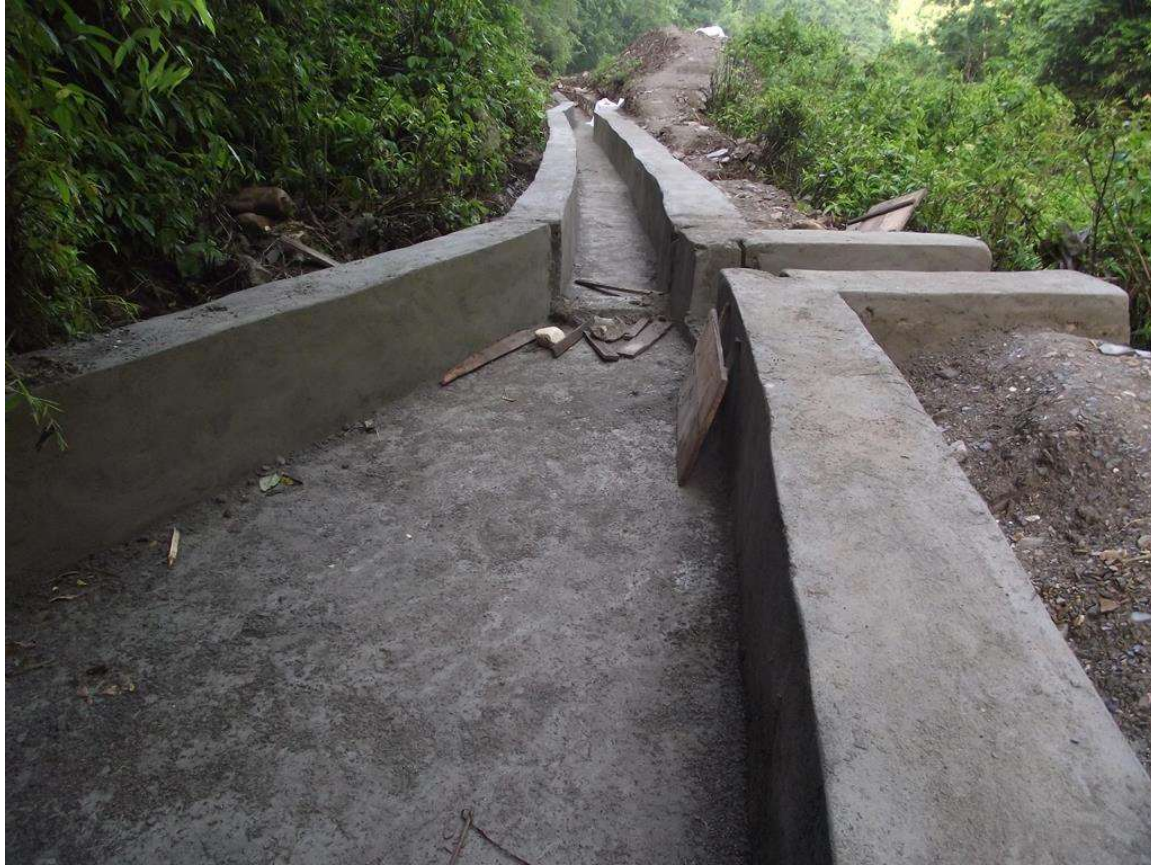
Intake and Washout

This picture depicts an intake constructed at the source. The Washout can be seen at the top right. There's a groove where a wooden plank goes in; this will help to control the water flow. Excess water will be let out so it does not overflow the canal walls. A dry stone wall will be erected at the right side of the intake.
